Manhole Inspection Summary

Manhole # S53AA_032MH

Insp Date: **3/5/08 9:06 AM**

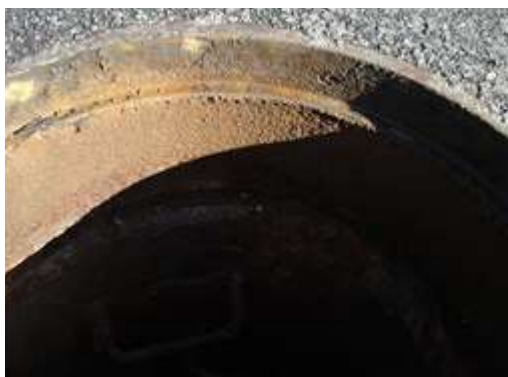
Defect 2

Frame Offset: **3** (in.) Condition: ☐ Sound ☐ Cracked ☒ **Leaks**

frame leaks

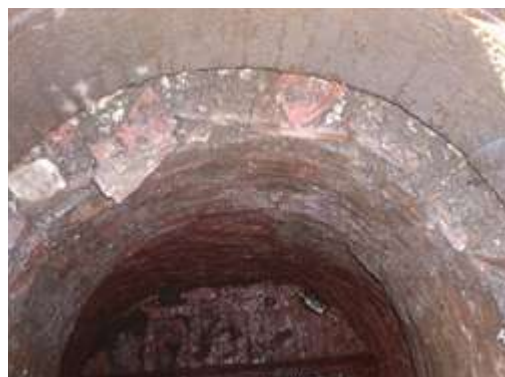
Defect 1

Condition: ☐ Sound ☐ Cracked ☐ Root Intrusion ☒ **Loose Brick** ☐ Deteriorated

Infiltration: ☐ None ☐ Joint ☐ Cracks ☐ Mortar ☐ Roots ☒ **Wall**

loose bricks

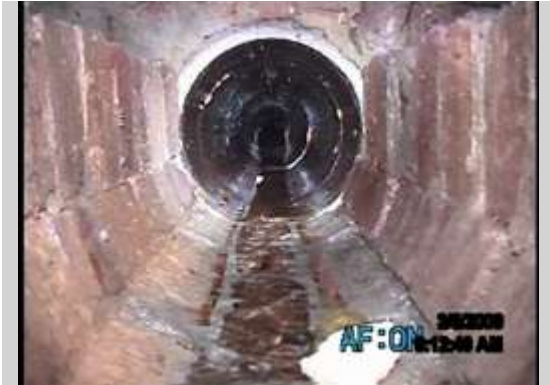
12 O'Clock Outflow

8 in. Circular Gravity Sewer
Pipe Out @ 12 O'Clock

Pipe Height: **8.4** (in.) Rod and Bar (Angled)
Pipe Material: **Clay** ☐ Pipe Lined
Invert Depth: **8.40** (ft.) Flow Characteristics: **Fast**
Deposits: ☒ None ☐ Mud ☐ Sludge ☐ Debris ☐ Grease
Silt Depth: (in.) Deposits Extent:
Infiltration: **None** Pipe Seal Cond: **Sound**

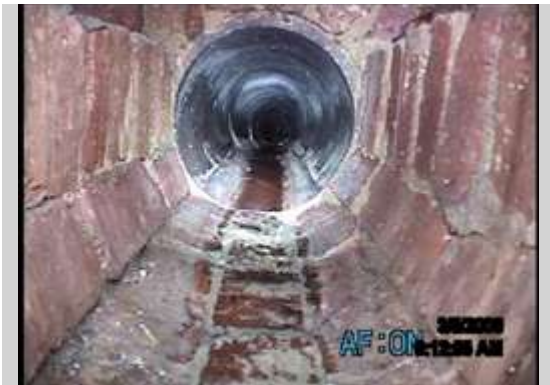
6 O'Clock Inflow

8 in. Circular Gravity Sewer
Pipe In @ 6 O'Clock

Pipe Height: **8.4** (in.) Rod and Bar (Angled)
Pipe Material: **Clay** ☐ Pipe Lined
Invert Depth: **8.10** (ft.) Flow Characteristics: **Fast**
Deposits: ☒ None ☐ Mud ☐ Sludge ☐ Debris ☐ Grease
Silt Depth: (in.) Deposits Extent:
Infiltration: **None** Pipe Seal Cond: **Sound**
